October 14, 2014

Re: Pre-Renovation Asbestos Survey and Lead-in-Paint Screening (9/29/14)

120 Broad Street; New London, CT

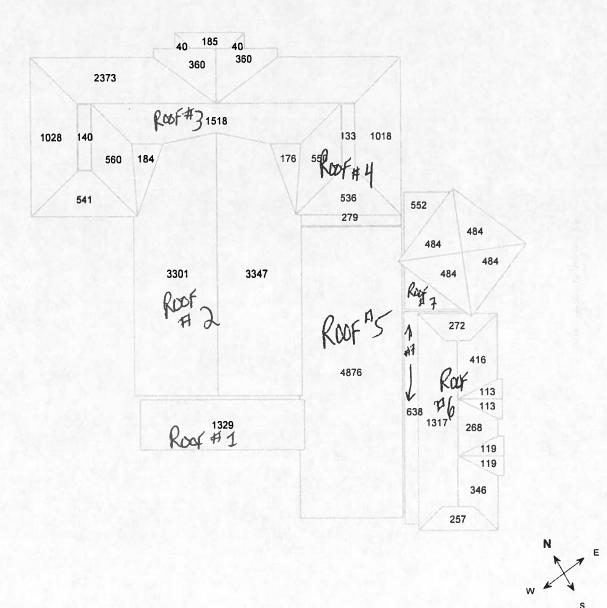
### **Area Diagram**

Sample #s	Material/Location Est	imated Affected Area
1-2	Glue Only/Roofs #1, 2, 5 –rubber membrane	12,853 sq. ft.
7-8	Hard Black Flashing Mastic/Roofs #1-5 -around penetrations Edge of roofs and on sidewalls	>100 sq. ft.
15	Built-Up Roofing/Roof #2 -edge of roof at bottom of siding to roo	of #1 80 sq. ft.
16-17	Built-Up Roofing/Roof #2 under insulation	6,648 sq. ft.

\*\*Inspector noted: Did not sample Roof #7 at client's request. The roofing company didn't have patch material for that type of membrane.

Any of the non-asbestos roofing materials with flashing attached will need to be treated as asbestos-contaminated and be cut out with the flashing when it is abated
