MS4 General Permit
City of New London 2023 Annual Report

Permit Number GSM 00111

January 1, 2023 – December 31, 2023

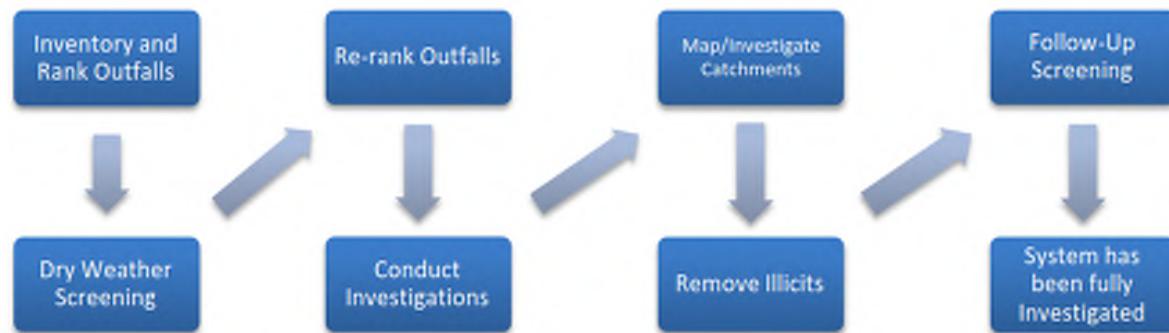
Figure 1-1. IDDE Investigation Procedure Framework

The IDDE investigation procedure framework is shown in Figure 1-1. The required timeline for implementing the IDDE program is shown in Table 1-2.

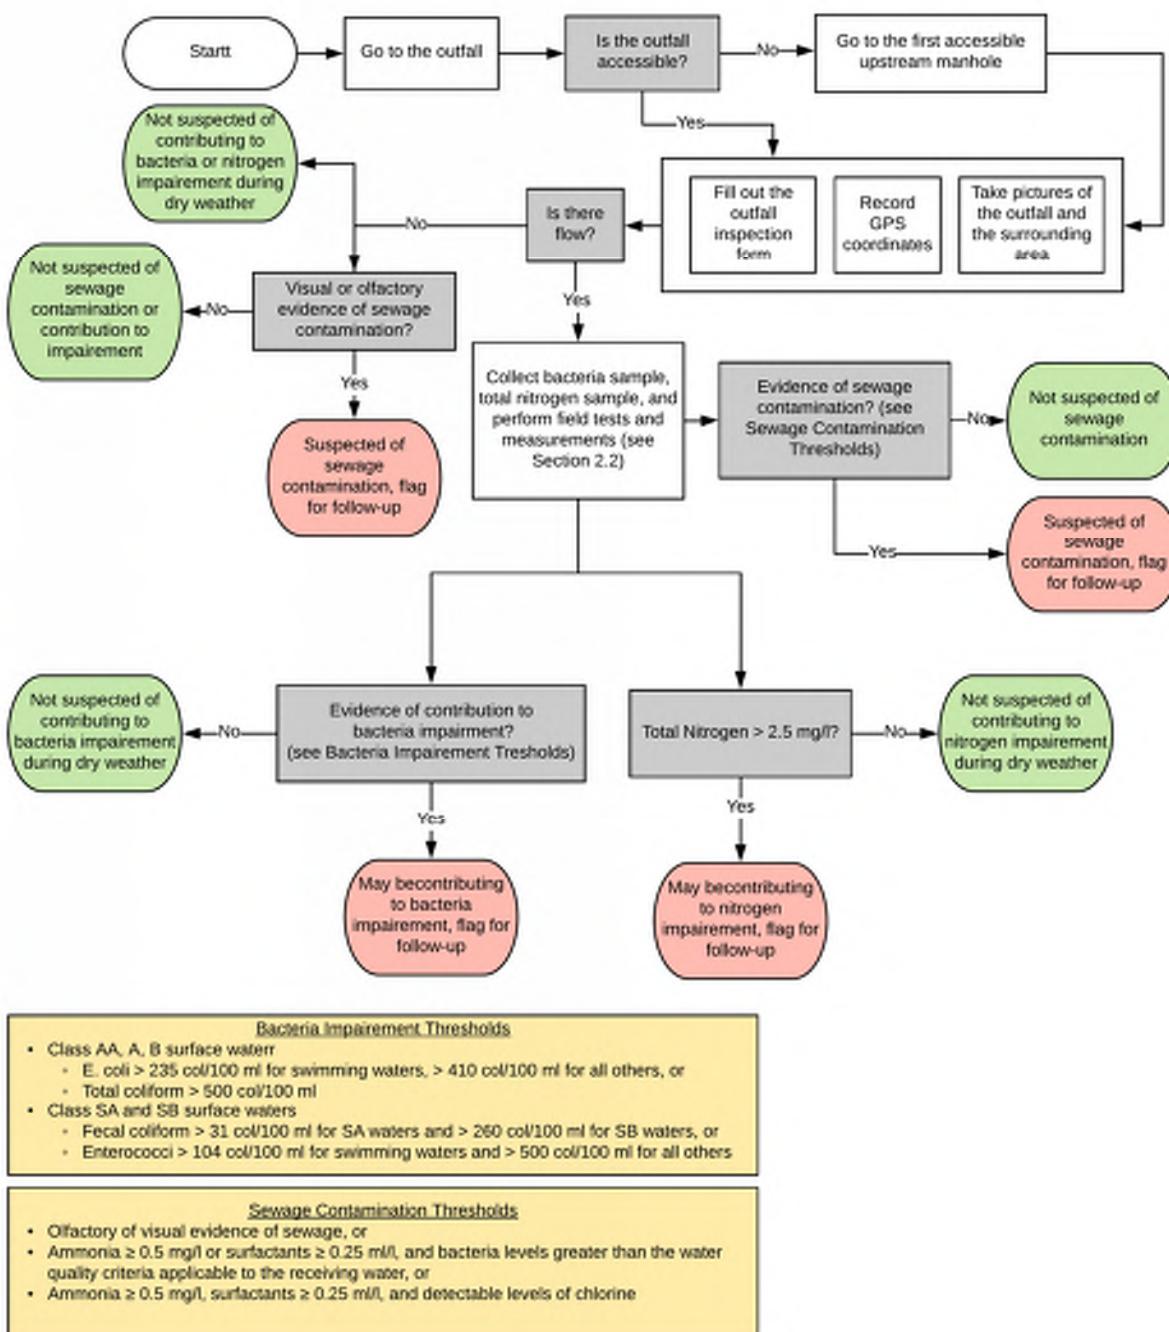
Figure 1. Outfall Inspection Procedures

There are three primary goals of the outfall inspection and dry weather sampling program: (1) inspect the condition of outfall, (2) check for signs of dry weather sewage contamination and (3) determine if the outfall is contributing to the impairment of an impaired waterbody during dry weather. Outfalls that are suspected of sewage contamination or contributing to a waterbody impairment will be identified for follow-up investigations that are not contained within this SOP.

Outfall inspections - The outfall inspection entails collecting basic information about that outfall and its condition. This information can be used to update the GIS data (e.g., outfall material, outfall diameter, etc.) and support replacement and rehabilitation planning. The outfall inspection information is entered into the Survey123 form.

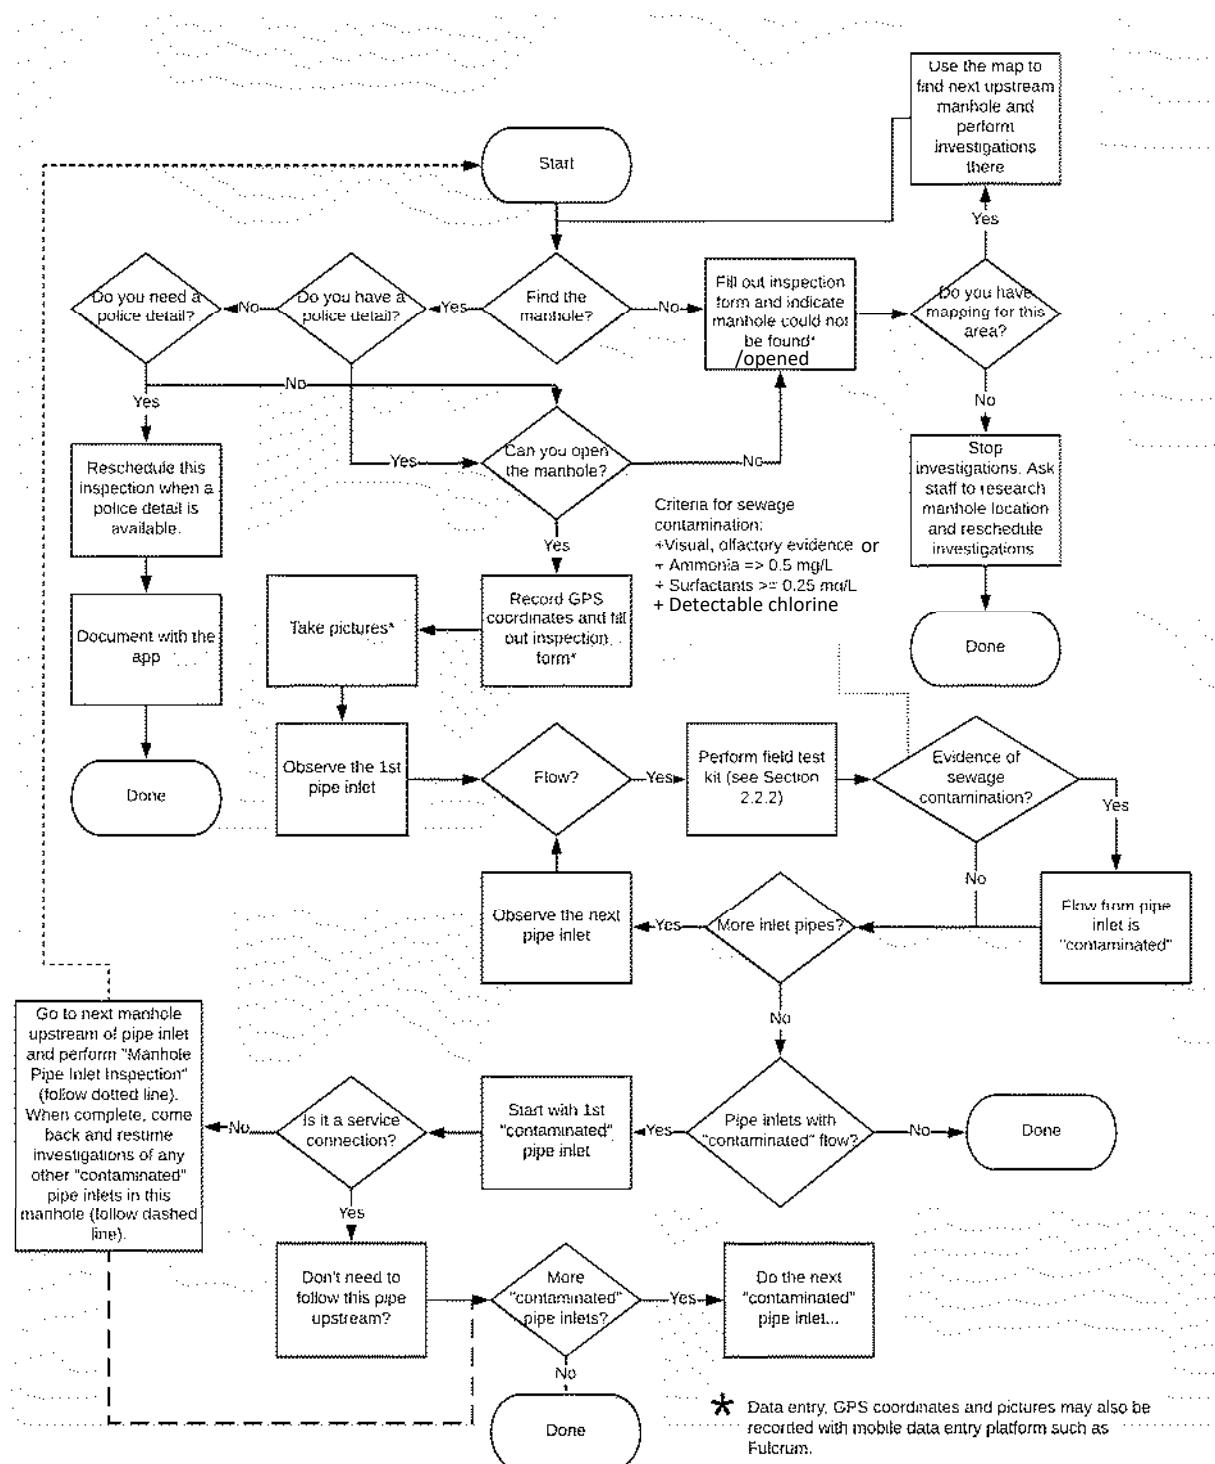
Figure 2. Upstream Source Tracking Procedures

The upstream source tracking begins at the first accessible manhole upstream of the outfall. The manhole's inlet pipes are inspected for visual/olfactory evidence of contamination and for dry weather flow. If dry weather flow is present, field test kits are used to measure ammonia, surfactants and chlorine. If any of the thresholds from Section 6.2 are exceeded, the flow from that pipe is considered to be potentially contaminated and the investigations continue upstream of that pipe. The investigations continue in this fashion, working upstream manhole by manhole until a manhole is found that has pipe inlets with no flow or no contaminated flow. This manhole is considered to be free of sewage contamination. Since contamination was present in the downstream manhole, the downstream pipe is flagged as suspected of being the source of contamination. The methodology for the upstream source tracking is detailed in the SOP for Dry Weather Outfall Screening and Sampling (see Appendix D).
